ASBESTOS PRE-RENOVATION SURVEY AND LIMITED LEAD RISK ASSESSMENT

MAPLE TOWERS

601 MAPLE AVENUE
CINCINNATI, OHIO 45229

ECS PROJECT NO. 53:5388

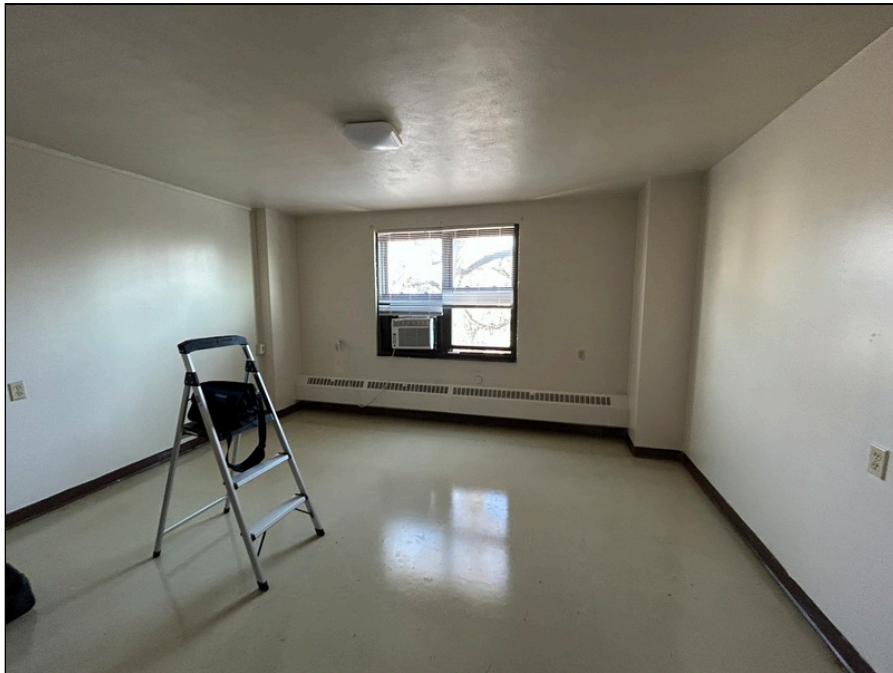
6 - View of HA-1, Drywall and ACM Joint Compound

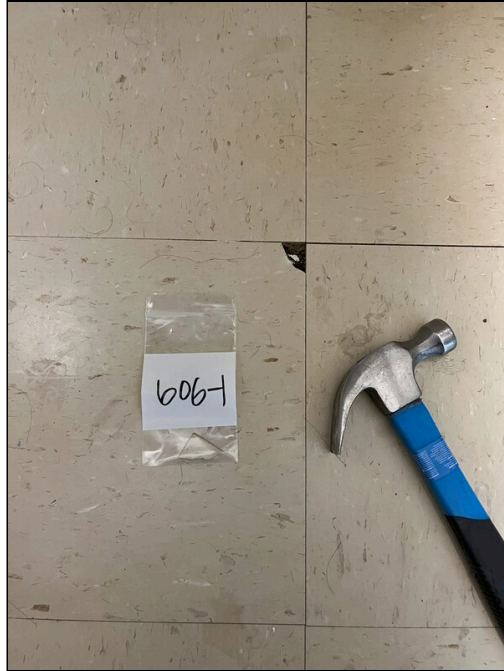
7 - View of HA-2, 12"x12" Beige w/ Brown Floor Tile w/ ACM Black Mastic

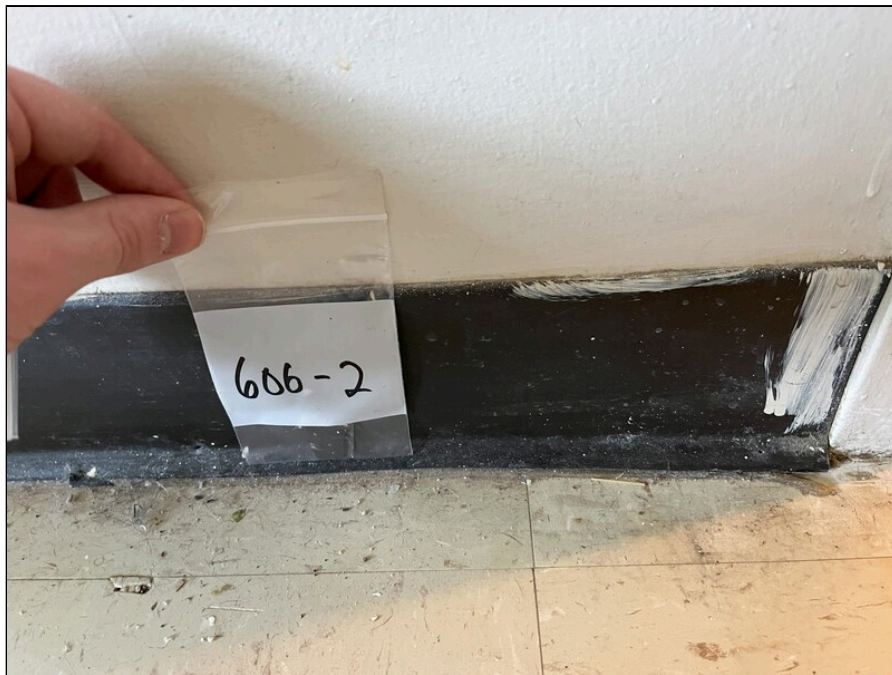
8 - View of HA-3, Black Cove Base

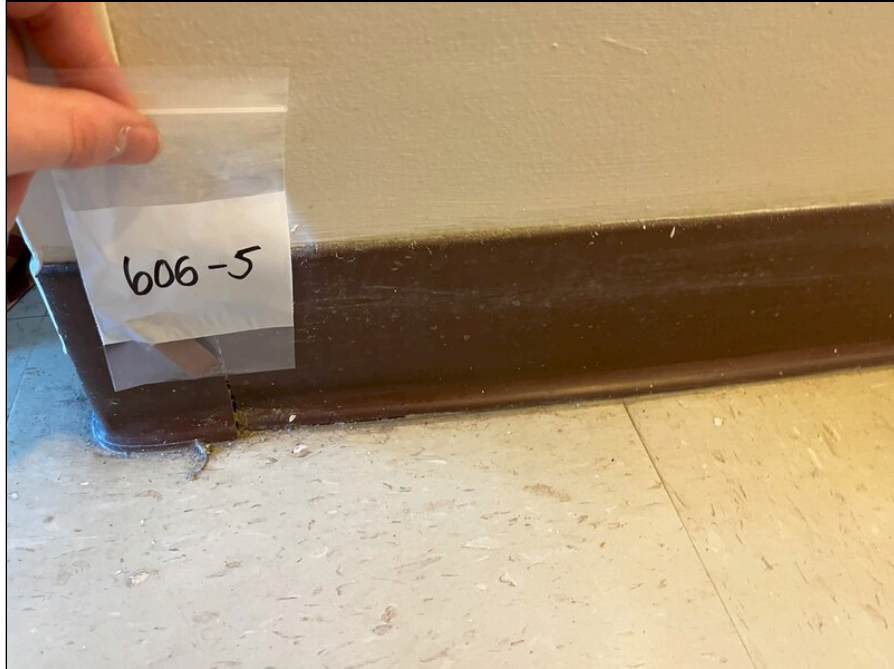
9 - View of HA-4, Brown Cove Base

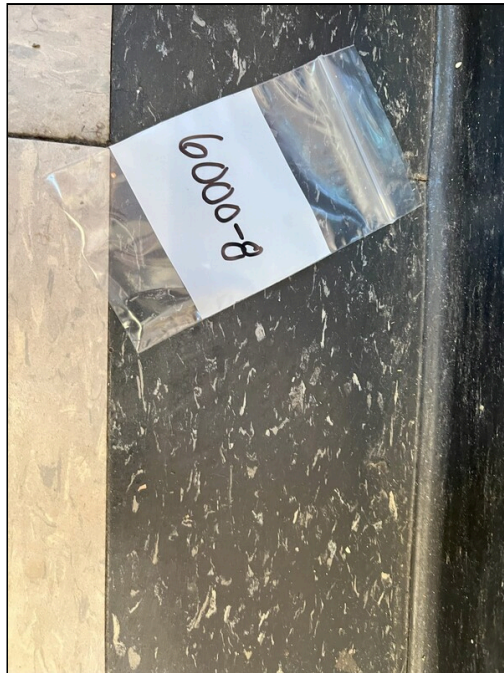
10 - View of HA-5, 12"x12" Black Floor Tile w/ ACM Black Mastic

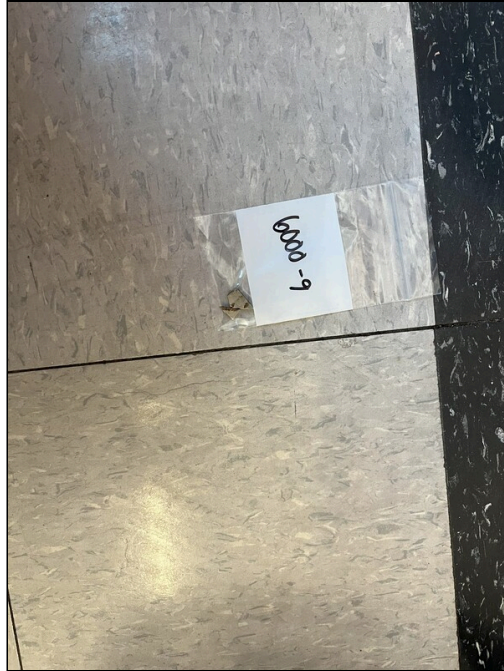
11 - View of HA-6, 12"x12" White/Gray Floor Tile w/ ACM Black Mastic

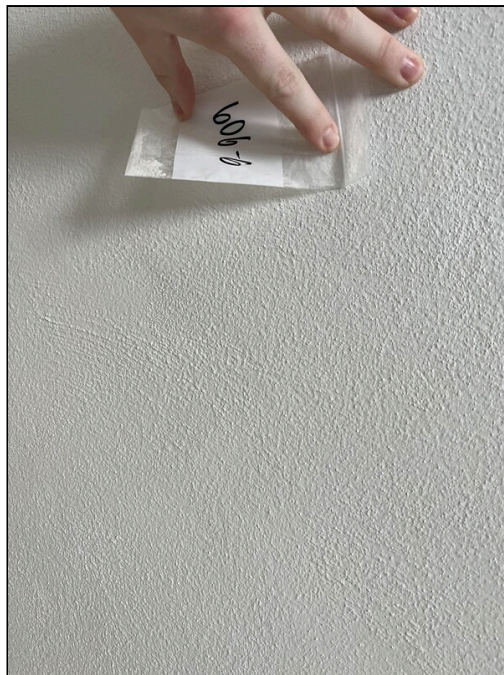
12 - View of HA-8, Ceiling Texture

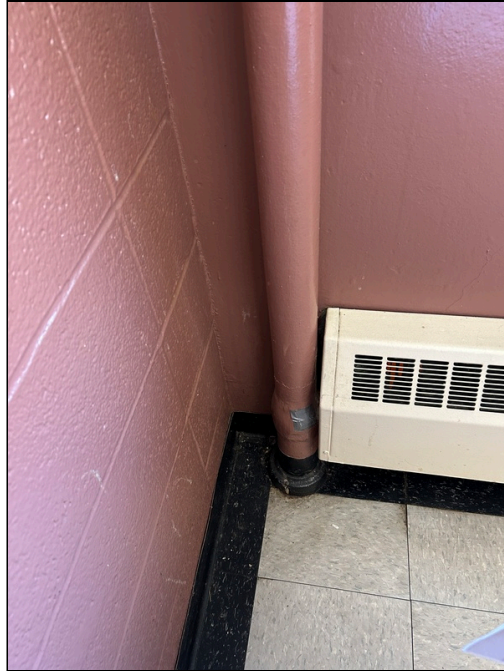
13 - View of HA-9, Pipe Joint

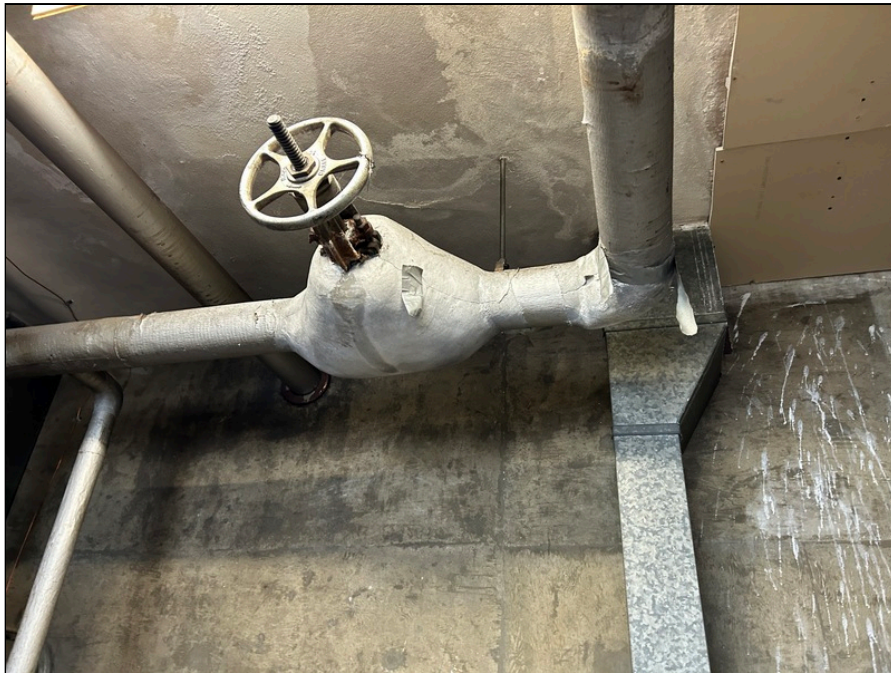
14 - View of HA-9, Pipe Joint

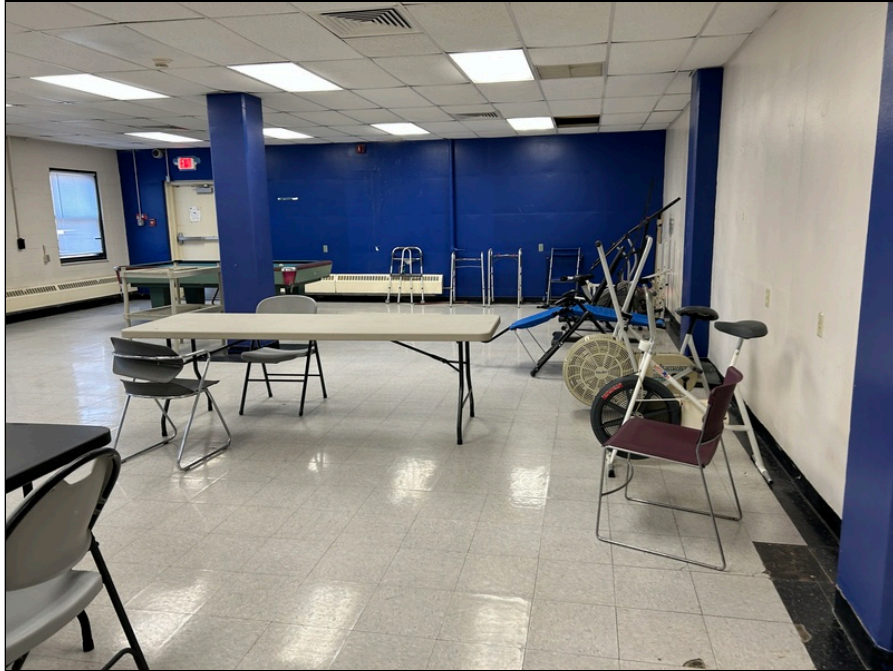
15 - View of typical finishes located within the Rec Room. View of HA-5 (Black Floor Tile w/ ACM Black Mastic), HA-6 (White Floor Tile w/ ACM Black Mastic), and HA-10 (2'x4' Pin & Fissure Ceiling Tile)

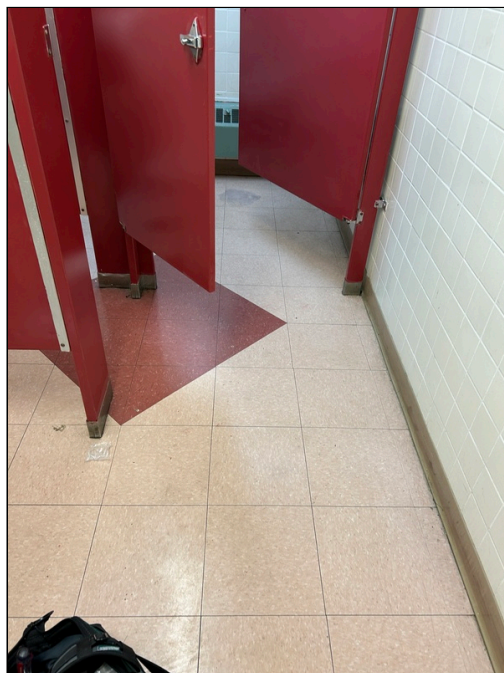
16 - View of HA-11 (12"x12" Red Floor Tile w/ ACM Black Mastic), HA-12 (12"x12" Light Pink Floor Tile w/ Yellow Mastic), and HA-19 (Cream Cove Base)

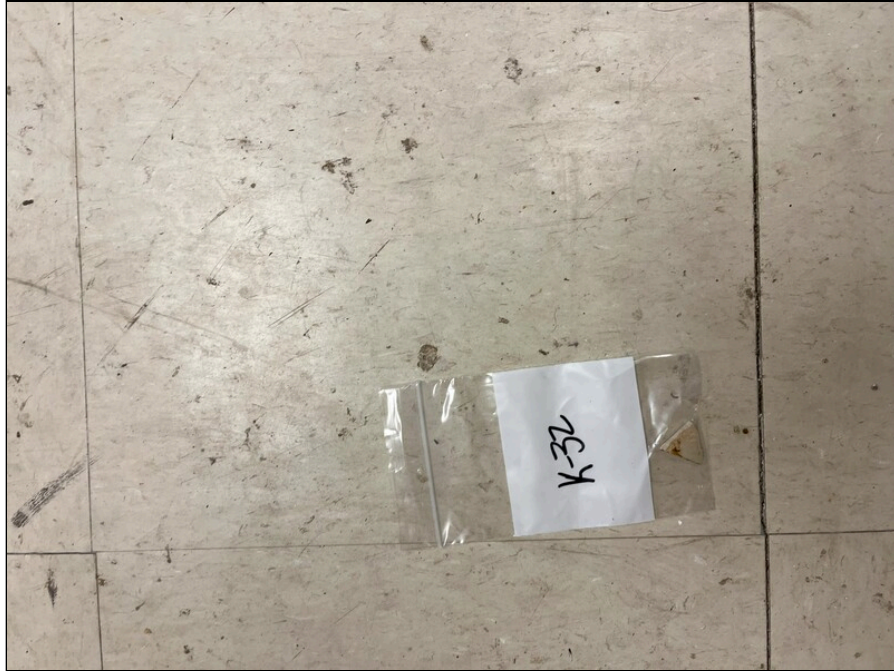
17 - View of HA-13, 12"x12" White w/ Gray Floor Tile w/ Yellow Mastic. Please note, HA-14, Floor tile w/ ACM Black Mastic, is located beneath HA-13.

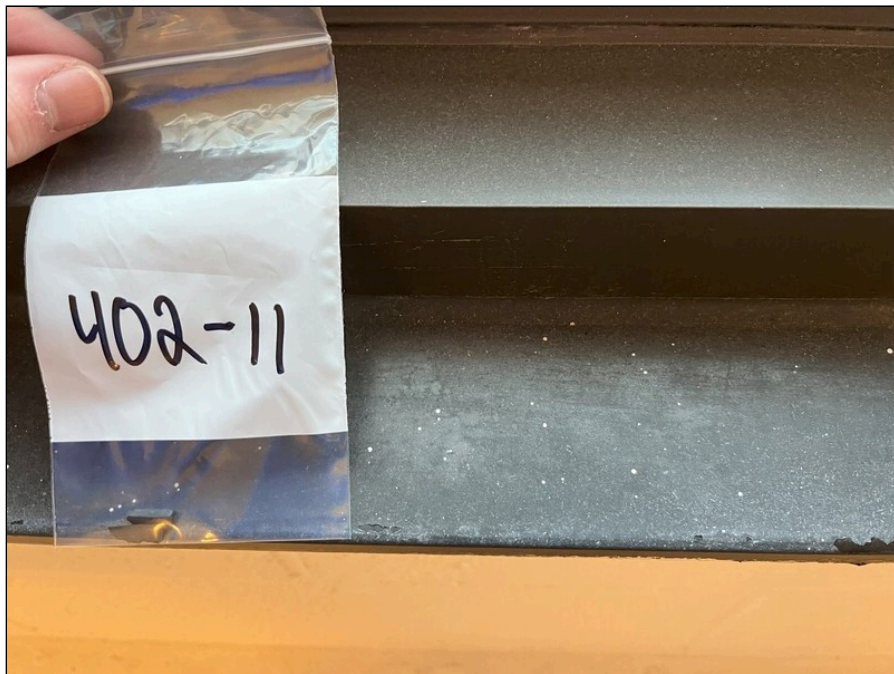
18 - View of HA-15, Black Caulk

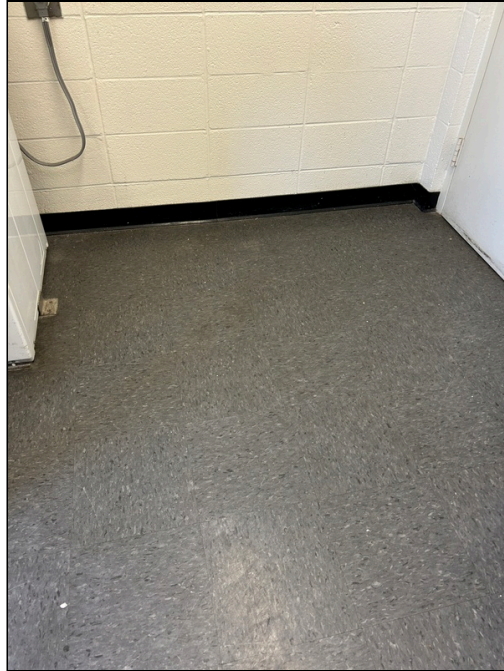
19 - View of general finishes located in the Laundry Rooms. View of HA-16, 12"x12" Dark Gray Floor Tile w/ Yellow Mastic.

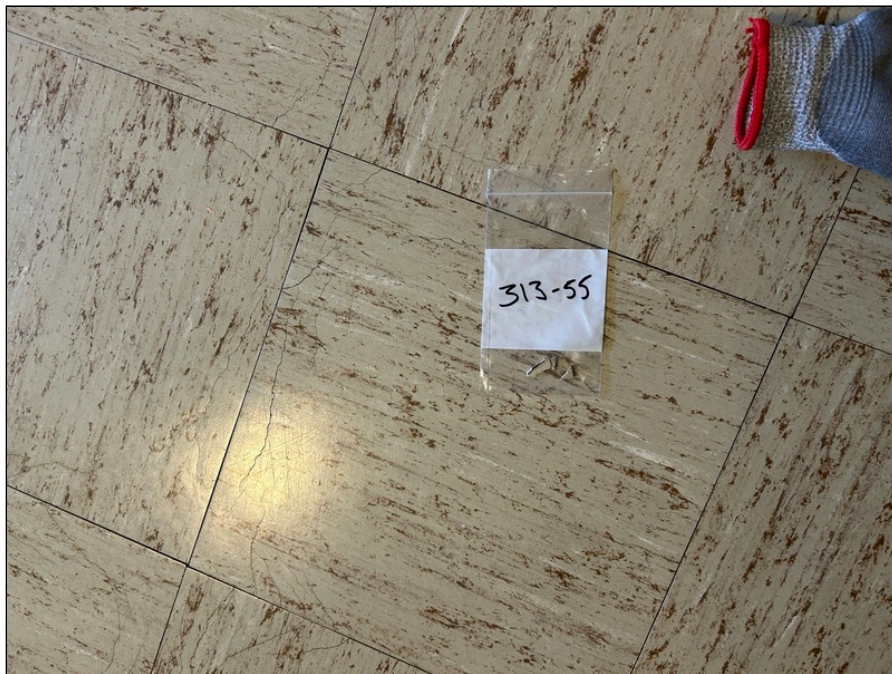
20 - View of HA-18, 12"x12" Brown Stripe Floor Tile w/ ACM Black Mastic. Please note, sample was erroneously labeled 313-55 and should be labeled 307-55.

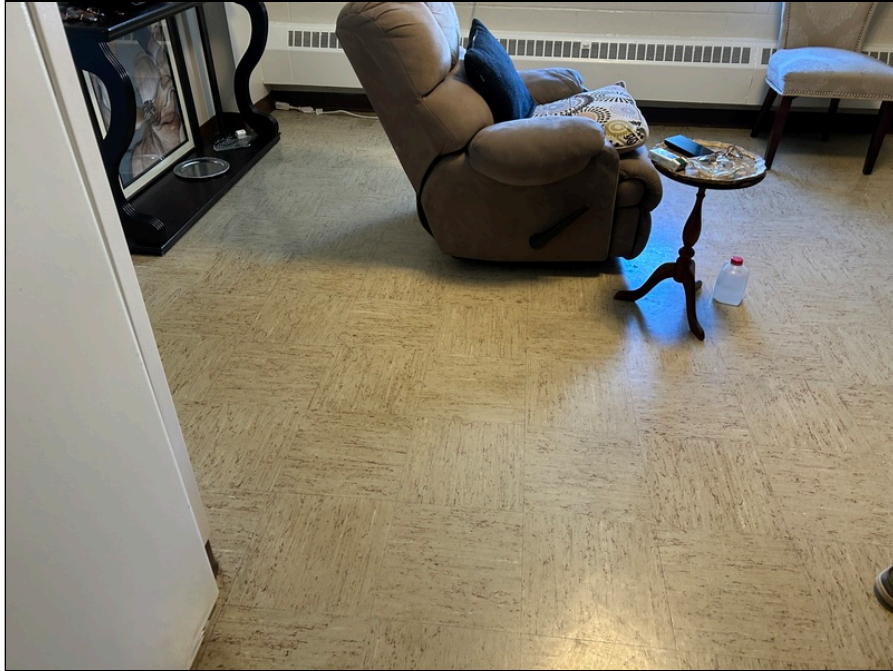
21 - View of HA-18, 12"x12" Beige/ Brown Floor Tile w/ ACM Black Mastic.

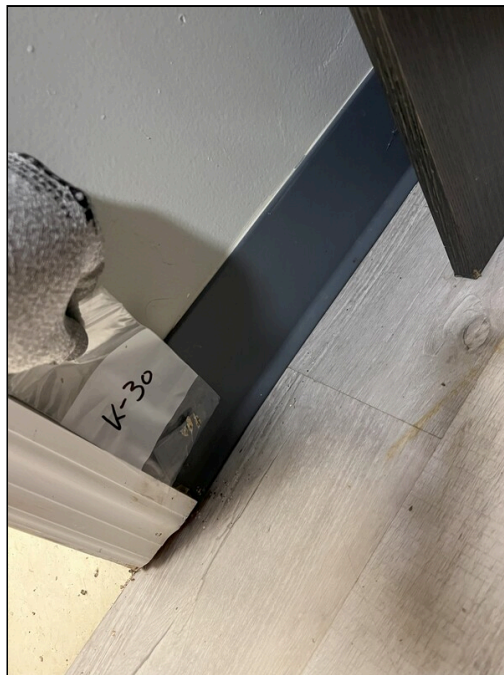
22 - View of HA-20, Gray Cove Base

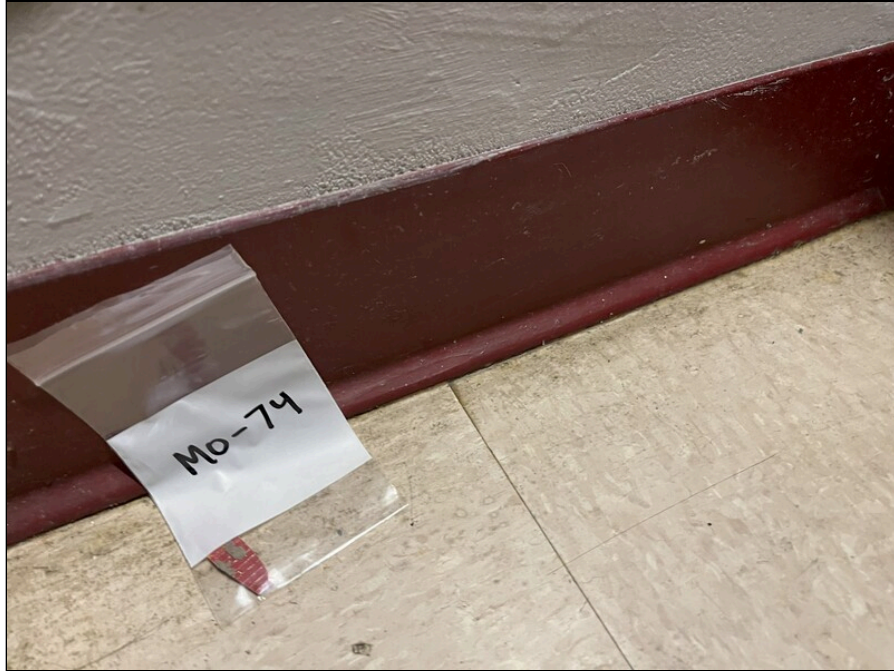
23 - View of HA-21, Red Cove Base

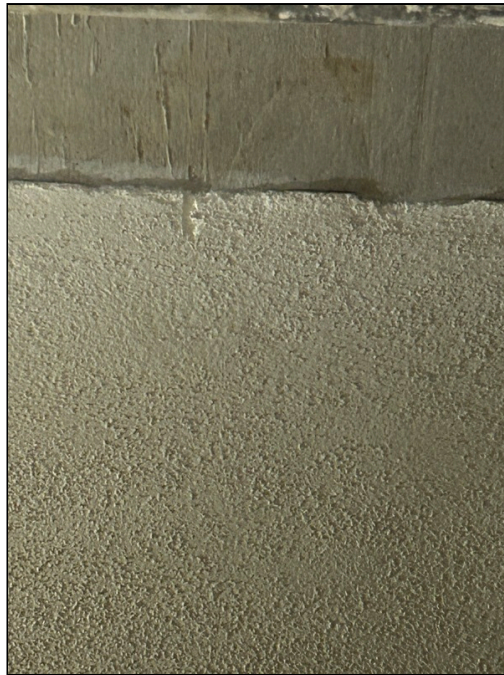
24 - View of HA-22, Ceiling Texture

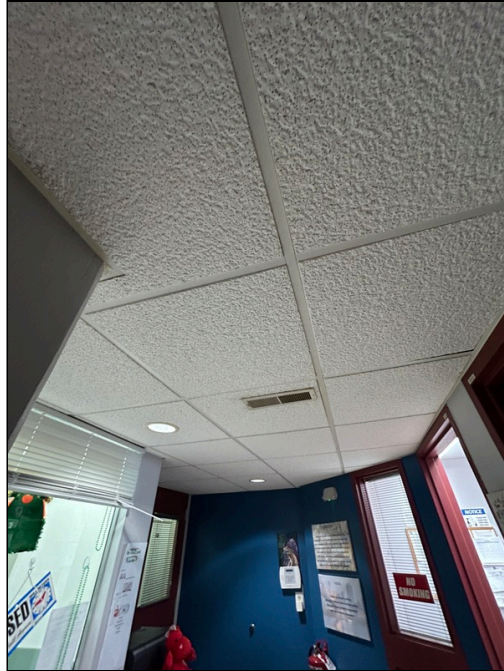
25 - View of HA-23, 2'x2' Rough Texture Ceiling Tile.

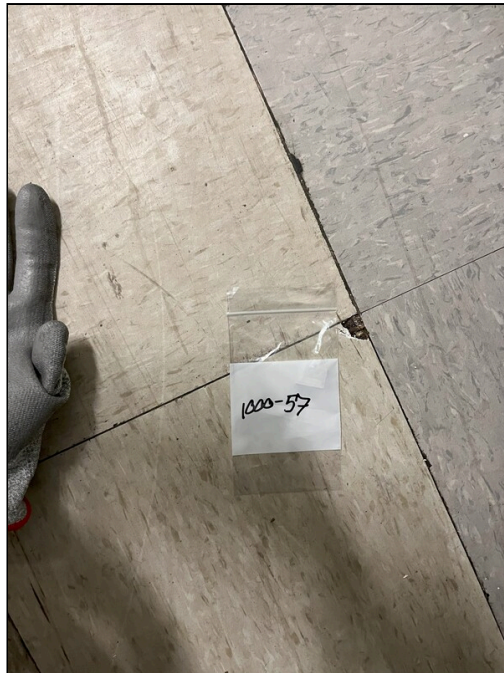
26 - View of HA-24, 12"x12" White Floor Tile w/ ACM Black Mastic

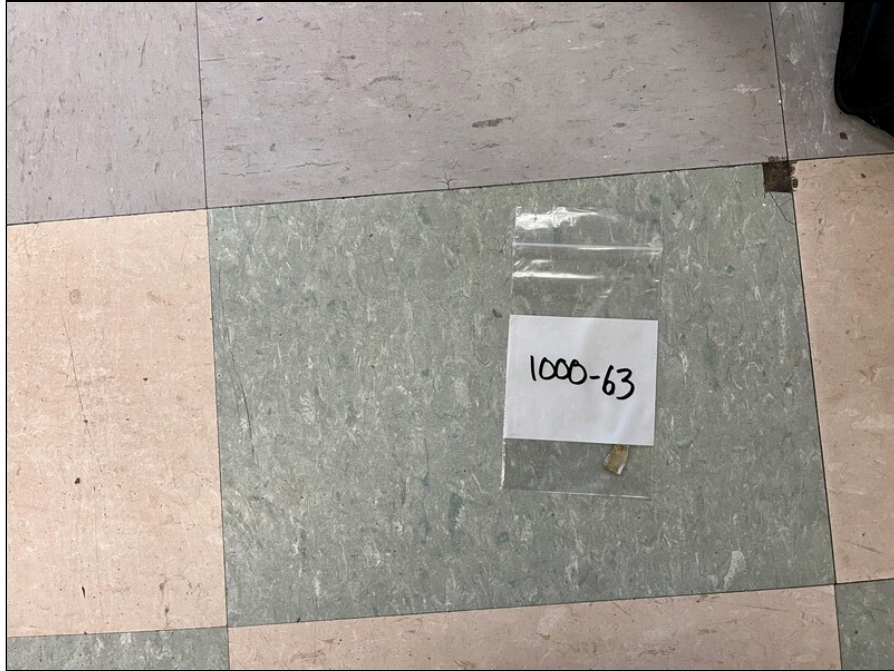
27 - View of HA-25, 12"x12" Green Floor Tile w/ Yellow Mastic

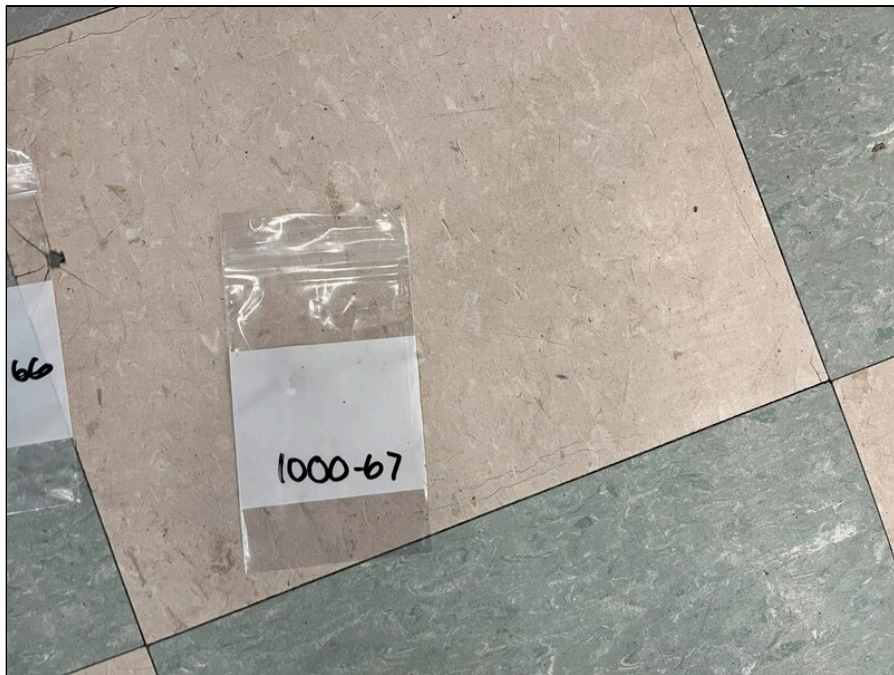
28 - View of HA-26, 12"x12" Cream Floor Tile w/ Yellow Mastic

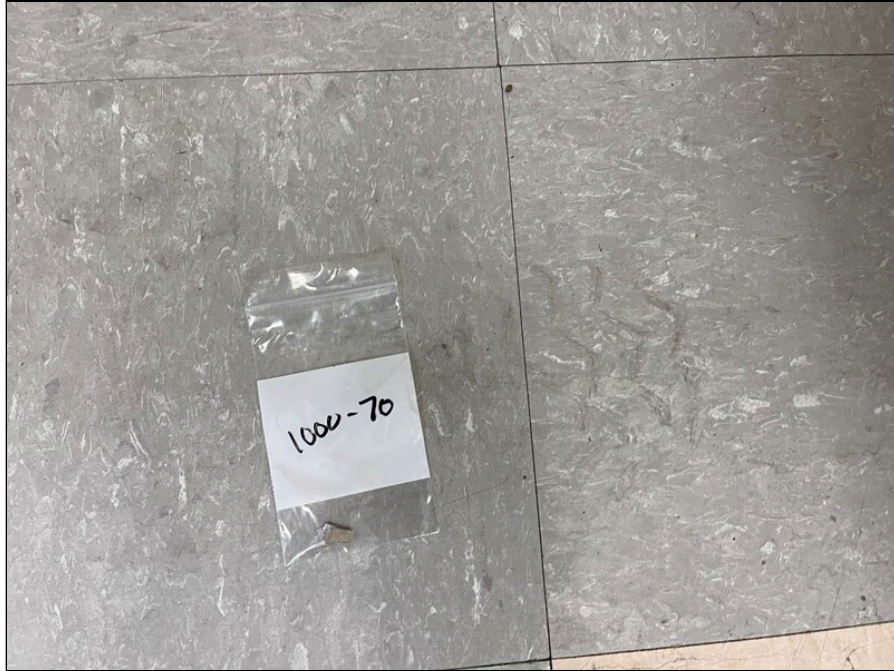
29 - View of HA-27, 12"x12" Light Gray Floor Tile w/ Yellow Mastic

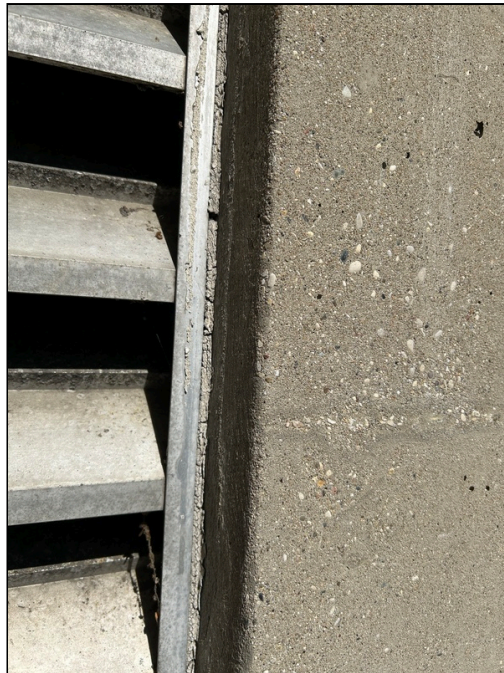
30 - View of HA-28, ACM White Vent Caulk

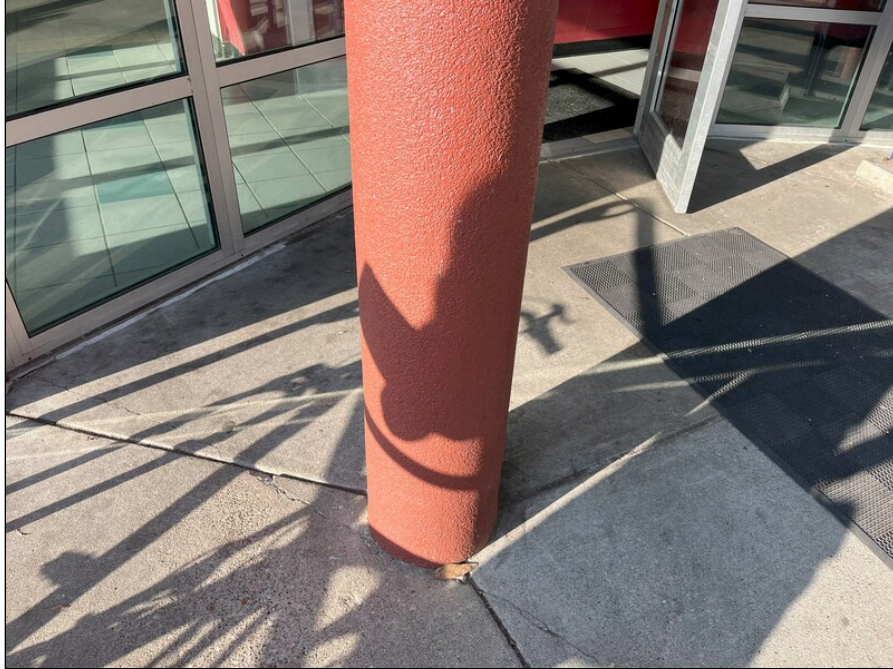
31 - View of HA-29, Exterior Stucco
